<ul style="list-style-type: none"> • HESITATION/STUMBLE—INTERMITTENT—4.9L, 5.0L, 5.8L AND 7.5L ENGINES • MISS—INTERMITTENT—4.9L, 5.0L, 5.8L AND 7.5L ENGINES • NO START/NO SPARK—INTERMITTENT—4.9L, 5.0L, 5.8L AND 7.5L ENGINES • STALL—INTERMITTENT—4.9L, 5.0L, 5.8L AND 7.5L ENGINES 	<p>Article No. 95-15-11</p>
--	---

FORD: 1993-1995 BRONCO, F-150-350 SERIES, F-47

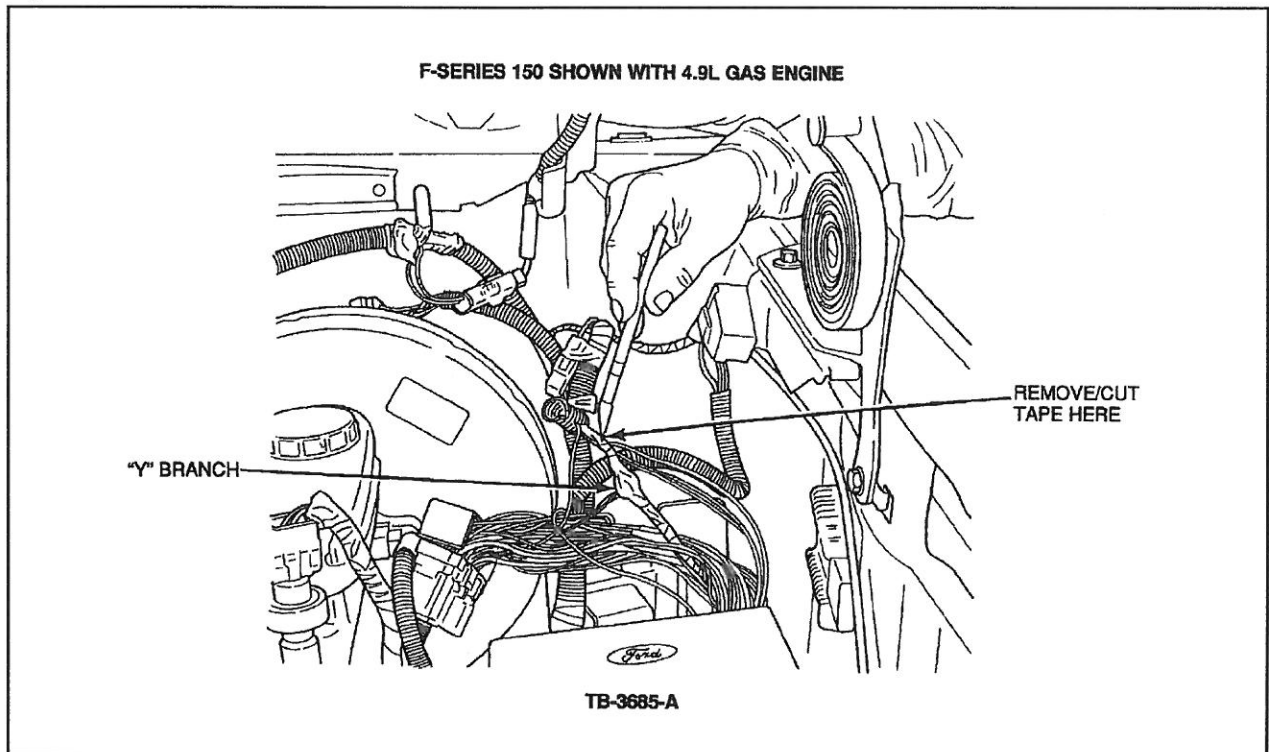
Figure 2 - Article 95-15-11

8. After the foil wrap is removed, look for the three (3) "grouped" wires in question at the "Y" branch. The three (3) wires are: PIP - Circuit 395 (GY/O), IGN GND - Circuit 259 (O/R), and SPOUT - Circuit 929 (PK).
9. Locate the (bare) electrical drain wire. Wire end is toward the ICM connector, again, about 5" (127mm) from the "Y" branch. Unravel wire from the top (ICM) end and down to the area where the bare wire makes contact with the three (3) wires mentioned above.
