## ***Technician Question and Answer Document for Inferred EBP***

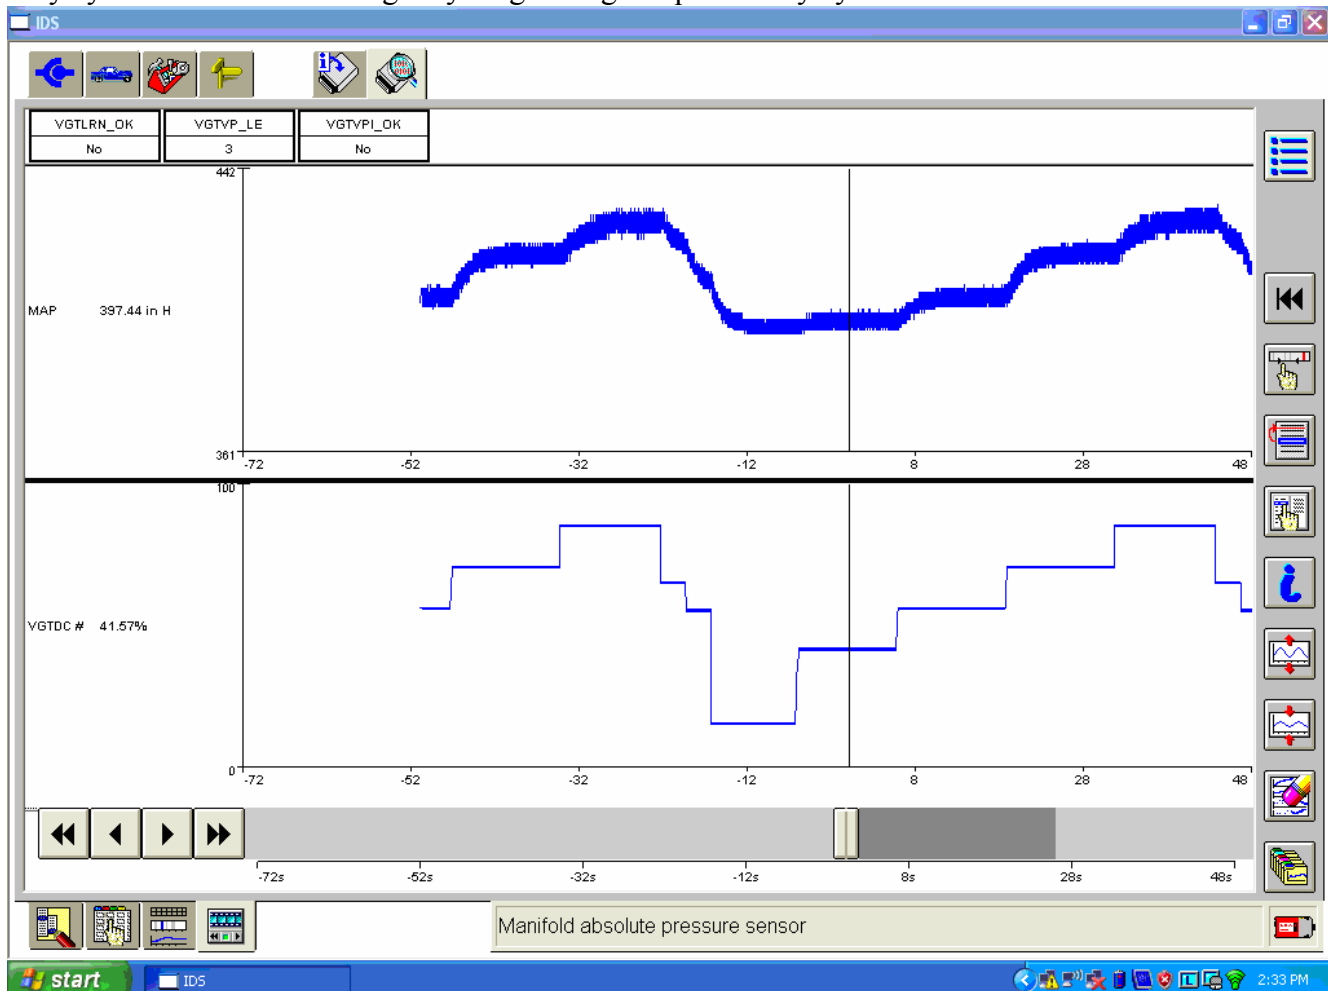
The turbocharger learning process looks like this: The picture shows a single learn cycle for the VGT duty cycle with the turbocharger cycling through required duty cycles

- ⇒ When one of these completes, the PID "VGTVP\_LE will increment by one
- ⇒ When the module has done 5 complete cycles (VGTVP\_LE > 5), the learn process will be considered mature (VGTVP\_OK = yes)
- ⇒ This individual cycle takes ~ 40 – 50 seconds, 5 cycles take ~ 5 minutes to complete, monitor VGTVP\_LE and VGTVP\_OK to determine if the adaptive has completed
