Technician High Pressure Pump Guide for the 7.3 Power Stroke Engine

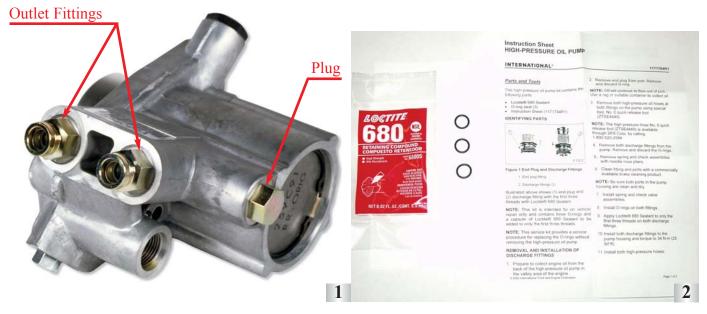
High pressure pumps with oil leaks at the fittings for the high pressure lines and the plug at the rear (see photo #1) can be repaired in the field using the following Ford part number 2C3Z-9G804-AA kit per TSB 03-17-01. This kit contains 3 o-rings, sealant, and instructions on how to clean and seal the fittings. Torque specs. for the fittings are also included.

Note: Threads must be cleaned, sealant applied to the first 3 threads and the fittings and plug tightened to proper specs.

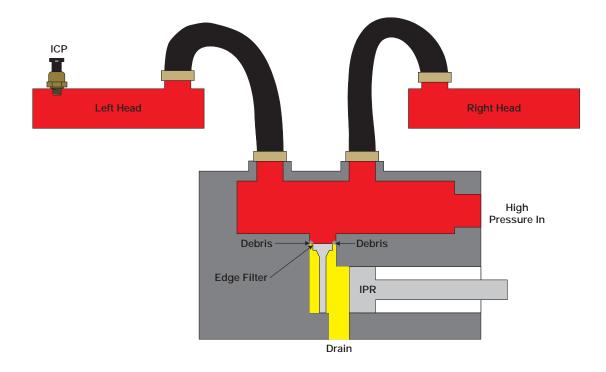
ICP more than 410 psi above command for at least 7.5 seconds can set a P1211 code. IPR with low duty cycle (less than 8% @ idle) and engine running, indicates a restriction in the drain circuit. This restriction is taking the place of the IPR valve, driving the IPR duty cycle lower, with higher than expected ICP. The excess restriction will be in the <u>reservoir</u>, <u>front cover</u>, <u>stuck IPR valve</u>, or <u>debris above the edge filter</u>. The drain path through the reservoir and front cover can be visually verified. Typically the pump or IPR must be replaced to repair this concern. Do not replace both components at the same time.

This often occurs after the oil pan is resealed where excess sealant is forced through the lube system (short circuit check valve) and trapped at the edge filter of the high pressure pump.

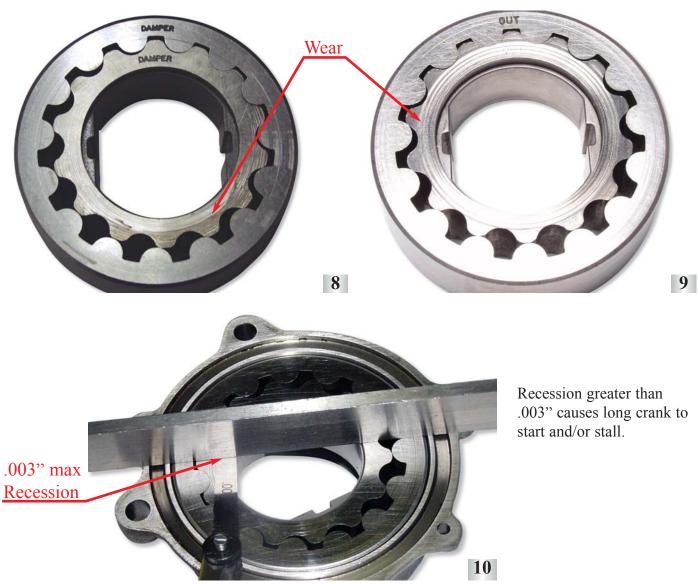
To measure pump wear, place a straight edge across the pump housing and use a feeler gauge to measure clearance between the inner gear and the straight edge. A pump with excess gear recession will contribute to hard start issues.

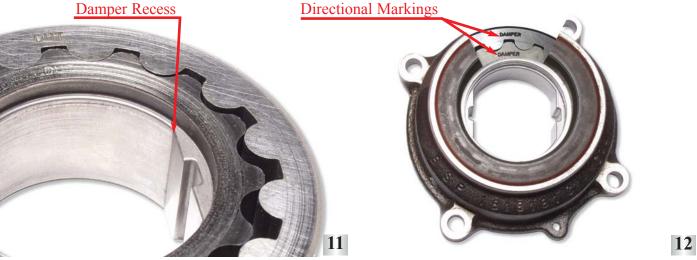
When replacing the pump, the directional markings ("OUT" or "Damper") must face the vibration damper. If installed correctly there is a recess that the vibration damper fits into on the inner gear. If installed incorrectly, the inner gear will cause major damage to the front cover.
